Manhole Inspection Summary

Manhole # S27A1_016MH

Insp Date: **4/18/08 10:03 AM**

Location Address: **Manokin St**

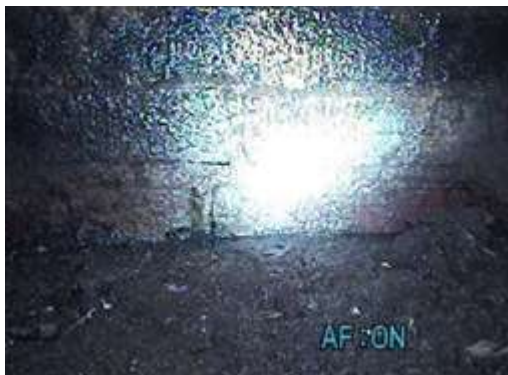
Miscellaneous

Infiltration: ☐ None ☐ Joint ☐ Cracks ☐ Mortar ☐ Roots ☒ **Wall**

Barrel infiltration and grease diposits

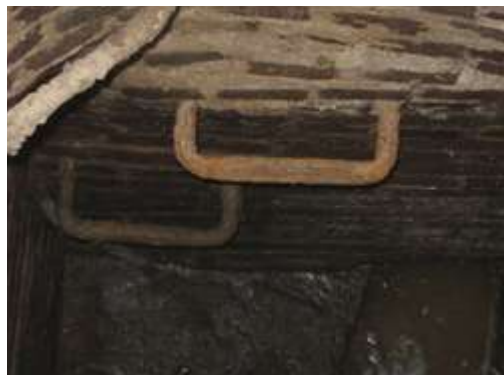
Defect 5

Count: **5** Missing: **0** ☒ **Corroded**

corroded steps

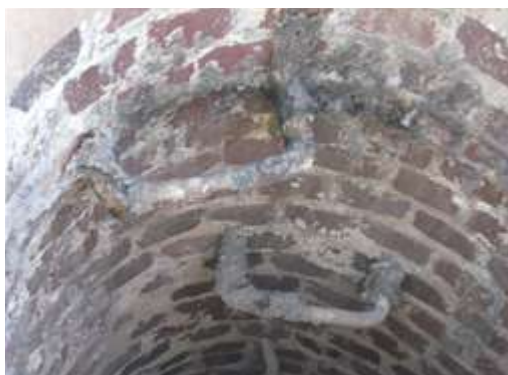
Defect 4

☒ **Evidence Of Surcharge** Depth: **7** (ft.) ☐ Active Surcharge Present

Evidence of surcharge on steps

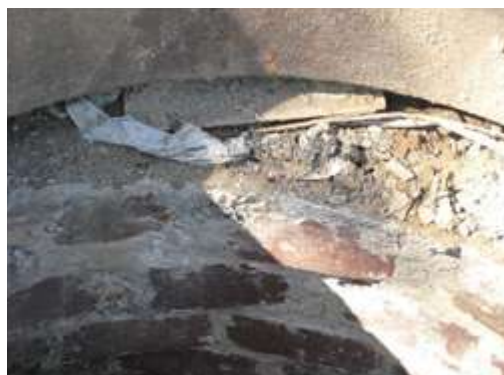
Defect 6

Condition: ☐ Sound ☐ Cracked ☐ Root Intrusion ☐ Loose Brick ☒ **Deteriorated**

deteriorated Chimney

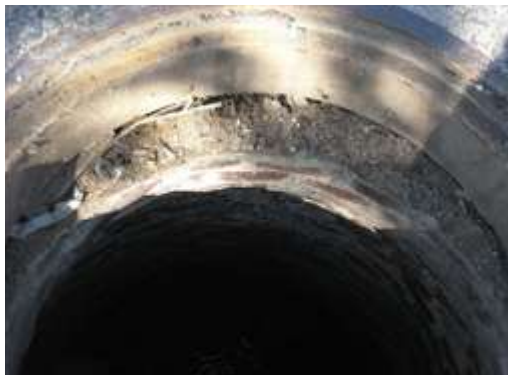
Defect 3

Offset: **3** (in.)

Offset chimney

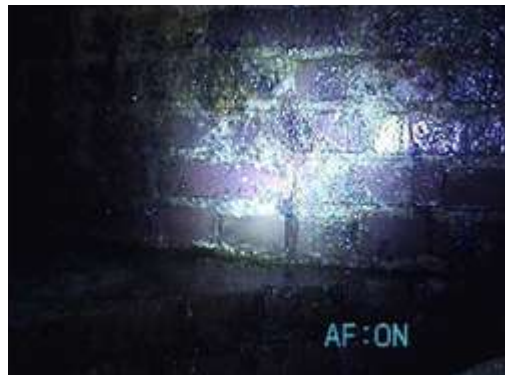
Defect 1

Barrel infiltration pic#1

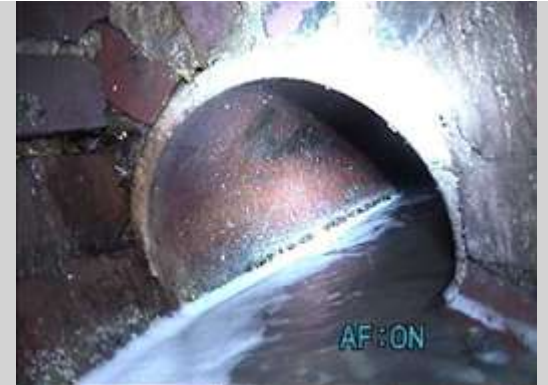
12 O'Clock Outflow

10 in. Circular Gravity Sewer
Pipe Out @ 12 O'Clock

Pipe Height: **10.8** (in.) Rod and Bar (Angled)
Pipe Material: **Clay** ☐ Pipe Lined
Invert Depth: **10.59** (ft.) Flow Characteristics: **Fast**
Deposits: ☒ None ☐ Mud ☐ Sludge ☐ Debris ☐ Grease
Silt Depth: **0** (in.) Deposits Extent:
Infiltration: **Evidence** Pipe Seal Cond: **Unknown**

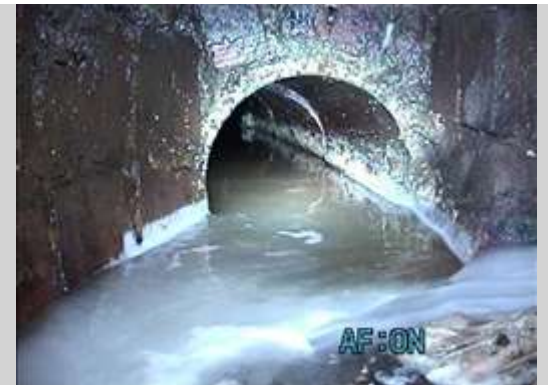
5 O'Clock Inflow

8 in. Circular Gravity Sewer
Pipe In @ 5 O'Clock

Pipe Height: **8.4** (in.) Rod and Bar (Angled)
Pipe Material: **Clay** ☐ Pipe Lined
Invert Depth: **10.43** (ft.) Flow Characteristics: **Slow**
Deposits: ☒ None ☐ Mud ☐ Sludge ☐ Debris ☐ Grease
Silt Depth: **0** (in.) Deposits Extent:
Infiltration: **Evidence** Pipe Seal Cond: **Unknown**

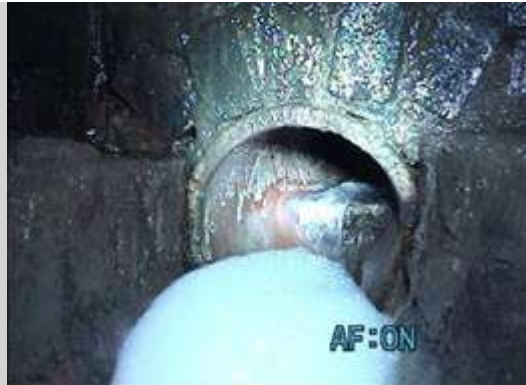
6 O'Clock Inflow

0 in. Circular Gravity Sewer
Pipe In @ 6 O'Clock

Infiltration: **Evidence** Pipe Seal Cond: **Unknown**
